## Protection against fire: the fire officer's view

### Fires in plastic consumer units A pattern of fires emerges

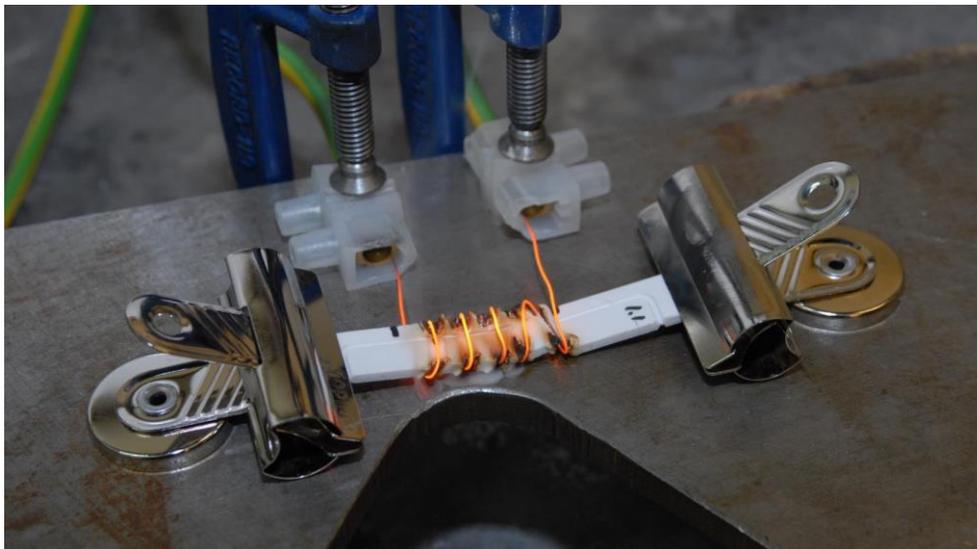
*Testing of a small piece of plastic from a consumer unit with a heated 'hot wire'.*

The team were also seeing more fires that were spreading beyond the consumer unit and putting people's lives at risk. Through a careful process of laboratory examinations and tests at Brigade consultant scientists Bureau Veritas, concern was raised about the flammability of the plastic enclosures of consumer units. Working closely with Electrical Safety First, more extensive tests of five plastic consumer units from different manufactures were carried out in 2012. These tests gave significant cause for concern due to the intensity of the fire and the levels of toxic smoke produced.

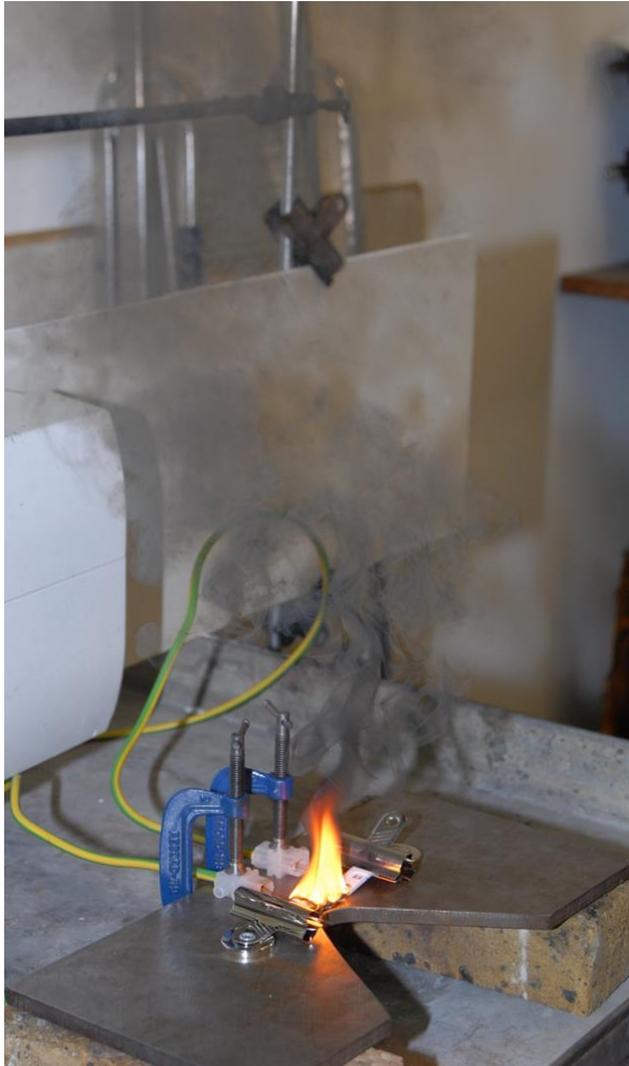
*Note the strong flame and large amount of toxic smoke being produced from the small plastic sample.*

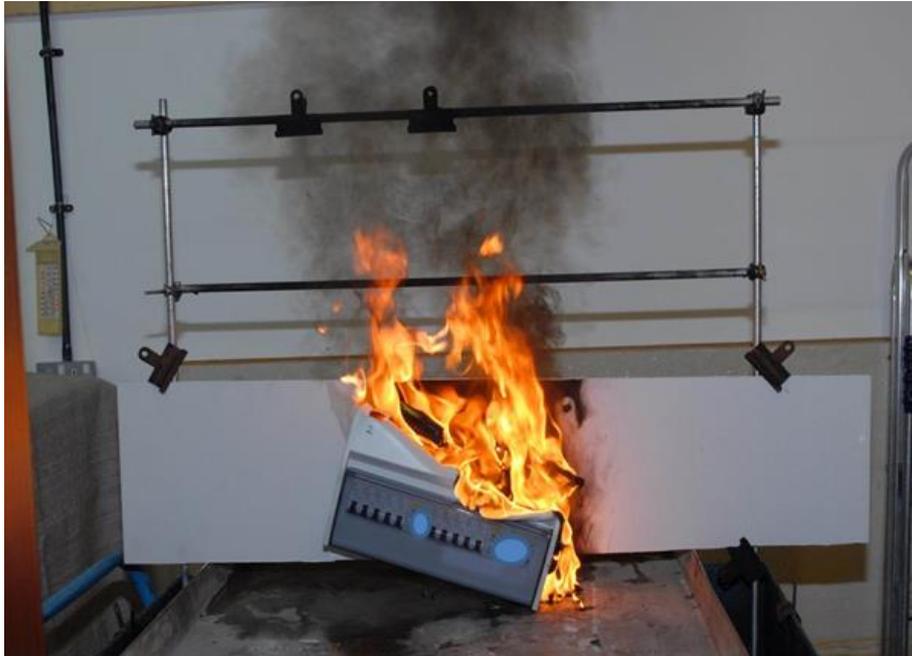
*A consumer unit test in progress - the fire rapidly burnt through mountings causing the test to be stopped.*

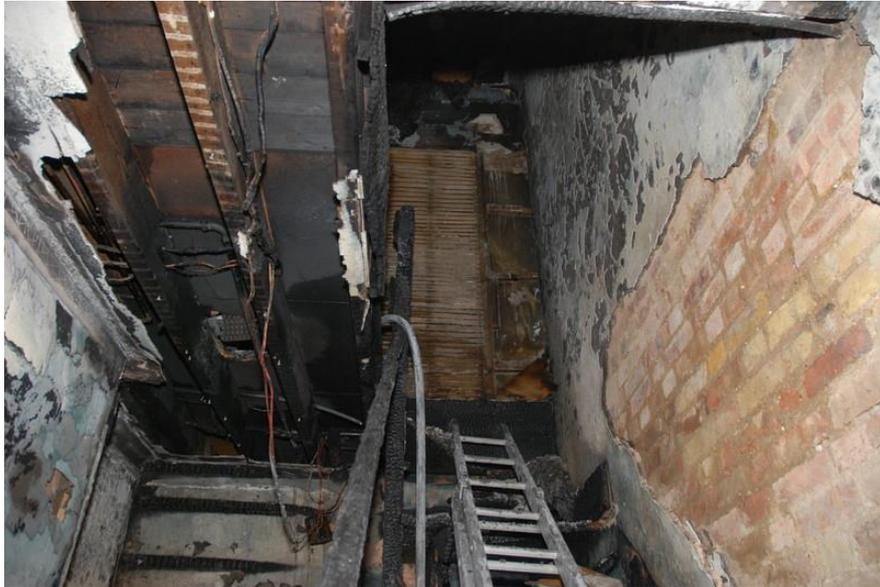
*Following a fire under the stairs, the stair treads have burnt through, the ceiling has failed and the plaster has come off the wall.*

A significant cause for concern when a consumer unit becomes involved in a fire is that it is commonly located on an escape route, for example, under the stairs or behind the front door. When this is combined with the fairly usual situation of coats, outdoor wear and other household items being stored nearby, once the fire starts, it often develops very quickly. London Fire Brigade was becoming extremely alarmed at the number of injuries occurring at such fires and the need for people to be rescued as they became trapped when the escape route was involved in fire.

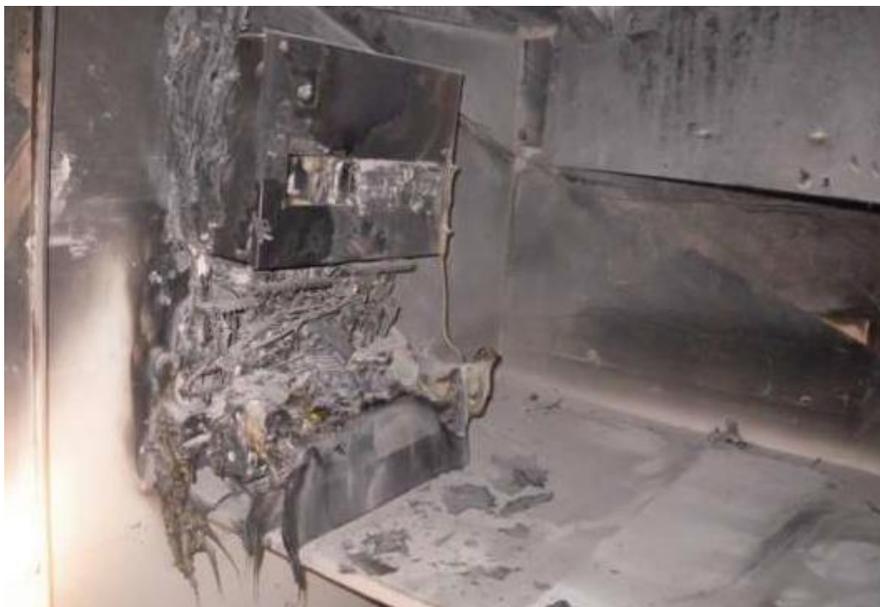
*This photo shows a fire involving a plastic consumer unit (bottom) and a metal consumer unit (top). In the experience of the LFB, when a fire originates within a metal consumer unit (even without sealed grommet holes and the plastic MCB cover failing), the fire is still generally contained to the consumer unit.*

7671, effectively requiring consumer unit enclosures in domestic households to be manufactured from non-combustible material (such as steel) or to be enclosed in a cabinet or enclosure constructed of non-combustible material. This new regulation is a welcomed step-change improvement in fire safety.

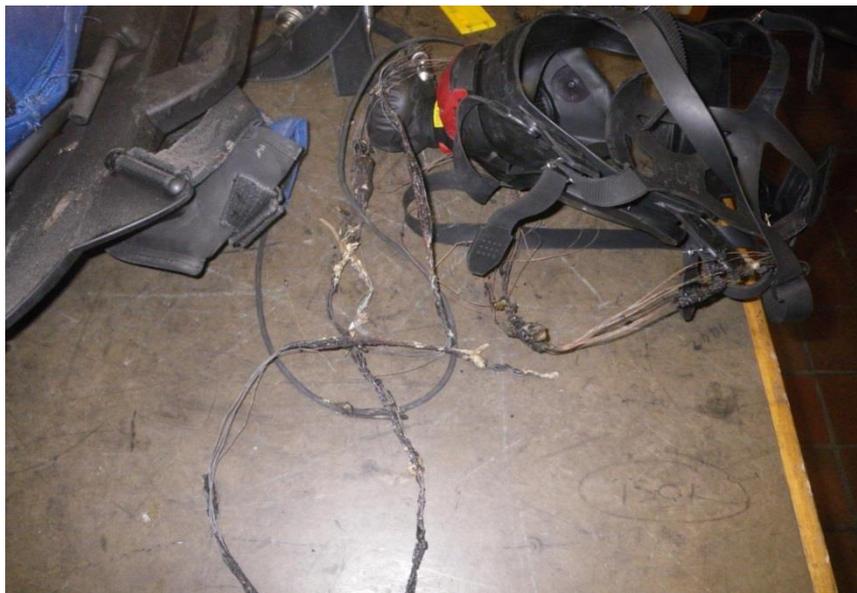
*This photo shows a face mask of a London firefighter who had a lucky escape after cables got tangled round the face mask.*

Firefighters enter buildings on fire to save life and reduce property damage, often working in intense heat, toxic smoke and with very poor visibility. To do this, they have to wear breathing apparatus and fire resistant clothing for protection. The problem has been that cables and plastic trunking have fallen from the ceilings at a very early stage during the fire's development, leaving the cables hanging. These cables have then become tangled around the firefighter's breathing apparatus, leaving them trapped and running out of air. Fire and Rescue Services such as London Fire Brigade have tried to reduce the risk to their firefighters by modifying the breathing apparatus and issuing firefighters with wire cutters, but this is only a 'best fix', it does not address the real issue.

The evidence that arose from such tragic incidents has been used to support change, which resulted in the new regulation in Amendment No. 3, requiring cables in escape routes to be adequately supported against their premature collapse in the event of a fire. The regulation precludes the use of non-metallic cable clips, cable ties or cable trunking as the sole measure of support. Firefighters have enough dangers to face without the additional risk of becoming entangled in dropping cables, so this new regulation is applauded.
